Contract #: 04-0120F4Cty: SF/ALA Rte: 80 PM: 13.2/13.9File #: 69.28**WELDING INSPECTION REPORT****Resident Engineer:**Pursell, Gary**Address:** 333 Burma Road**City:** Oakland, CA 94607**Report No:** WIR-004044**Date Inspected:** 27-Aug-2008**Project Name:** SAS Superstructure**OSM Arrival Time:** 1330**Prime Contractor:** American Bridge/Fluor Enterprises, a JV**OSM Departure Time:** 2230**Contractor:** Zhenhua Port Machinery Company, Ltd (ZPMC), Changxing Island **Location:** Shanghai, China**CWI Name:** See below**CWI Present:** Yes No**Inspected CWI report:** Yes No N/A**Rod Oven in Use:** Yes No N/A**Electrode to specification:** Yes No N/A**Weld Procedures Followed:** Yes No N/A**Qualified Welders:** Yes No N/A**Verified Joint Fit-up:** Yes No N/A**Approved Drawings:** Yes No N/A**Approved WPS:** Yes No N/A**Delayed / Cancelled:** Yes No N/A**Bridge No:** 34-0006**Component:** OBG Fabrication**Summary of Items Observed:**

Caltrans Quality Assurance (QA) Inspector, Mr. Paul Dawson, arrived on site at the Zhenhua Port Machinery Company (ZPMC) facility at Changxing Island, in Shanghai, China, for the purpose of monitoring welding and fabrication of the San Francisco / Oakland B

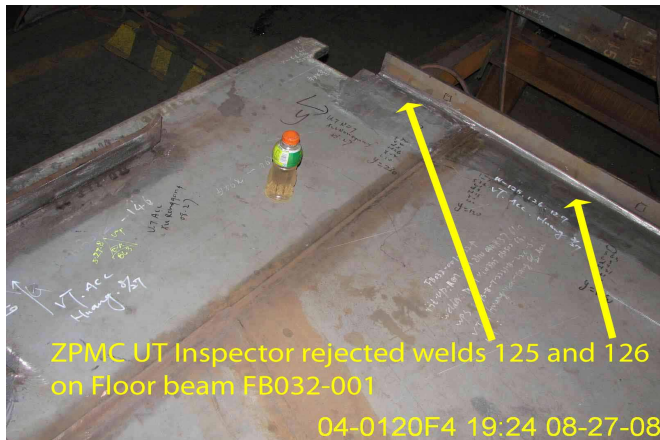
The QA Inspector observed floor beam welds FB030-001-127, FB032-001-125, FB032-001-126 and FB032-001-127 had previously been ultrasonically inspected by ZPMC Inspection personnel earlier today and each of these four welds is marked as "UT Reject".

QA performed AWS D1.5 ultrasonic inspection of floor beam welds FB030-001-125, FB030-001-126, FB030-001-146 and FB032-001-146 and items observed appear to comply with project specifications. Each of these welds had been identified as UT Accept by ZPMC inspection personnel earlier today. See the photographs below and the TL6027 ultrasonic test report for additional information.
